Report of Thorough Examination and Test by a Competent Person of Local Exhaust Ventilation Equipment

**Another County Council
Calder High School
Main Street
Calder
AE2 7QT**

Contract No: ROHSS070211-1

Description: LEV Plant – Wood Working Workshop

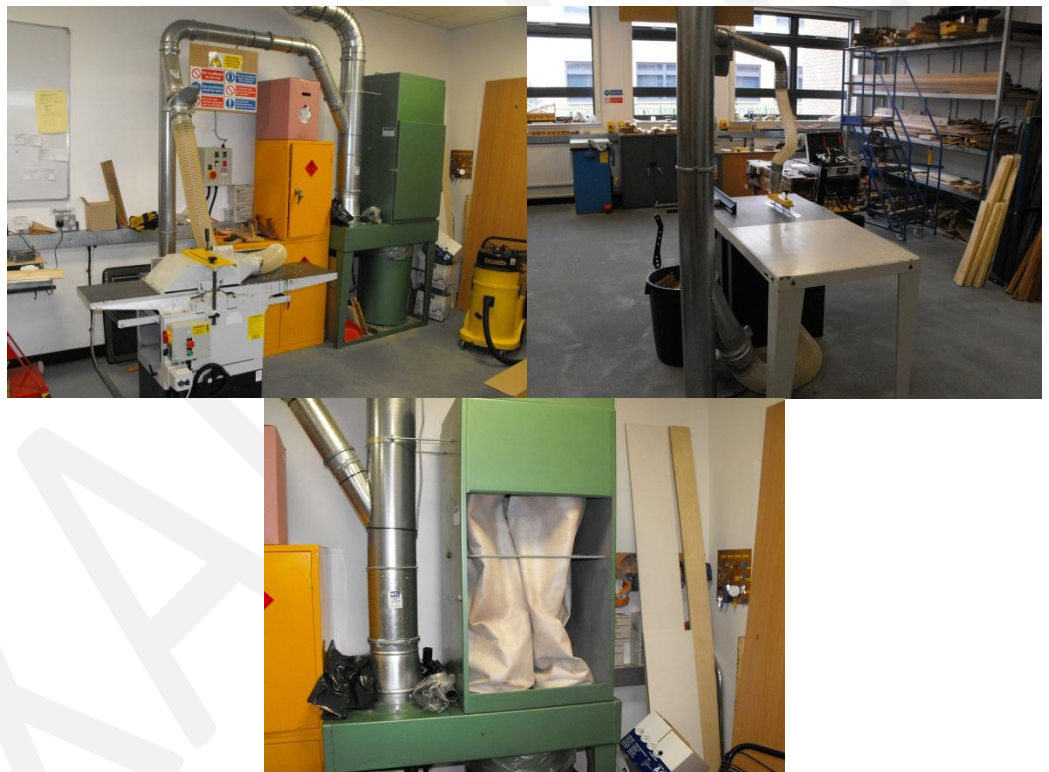
18. *Photographs of System.*

| 16. <i>Observations.</i> | The system was found to be extracting the contaminant satisfactorily. Traces of sawdust were found in the filter chamber, however no apparent damage to | | |

the filters or cover seals was evident. The filter chamber should be vacuum cleaned and monitored for further escape of saw dust.

The duct velocity at the overhead (Top Hood) circular saw duct was below the recommended 15 m/s, however the contaminant was being controlled as demonstrated with the dust lamp.

We would recommend that the ducting and filters are thoroughly cleaned annually or in accordance with the manufacturer / installers instructions.

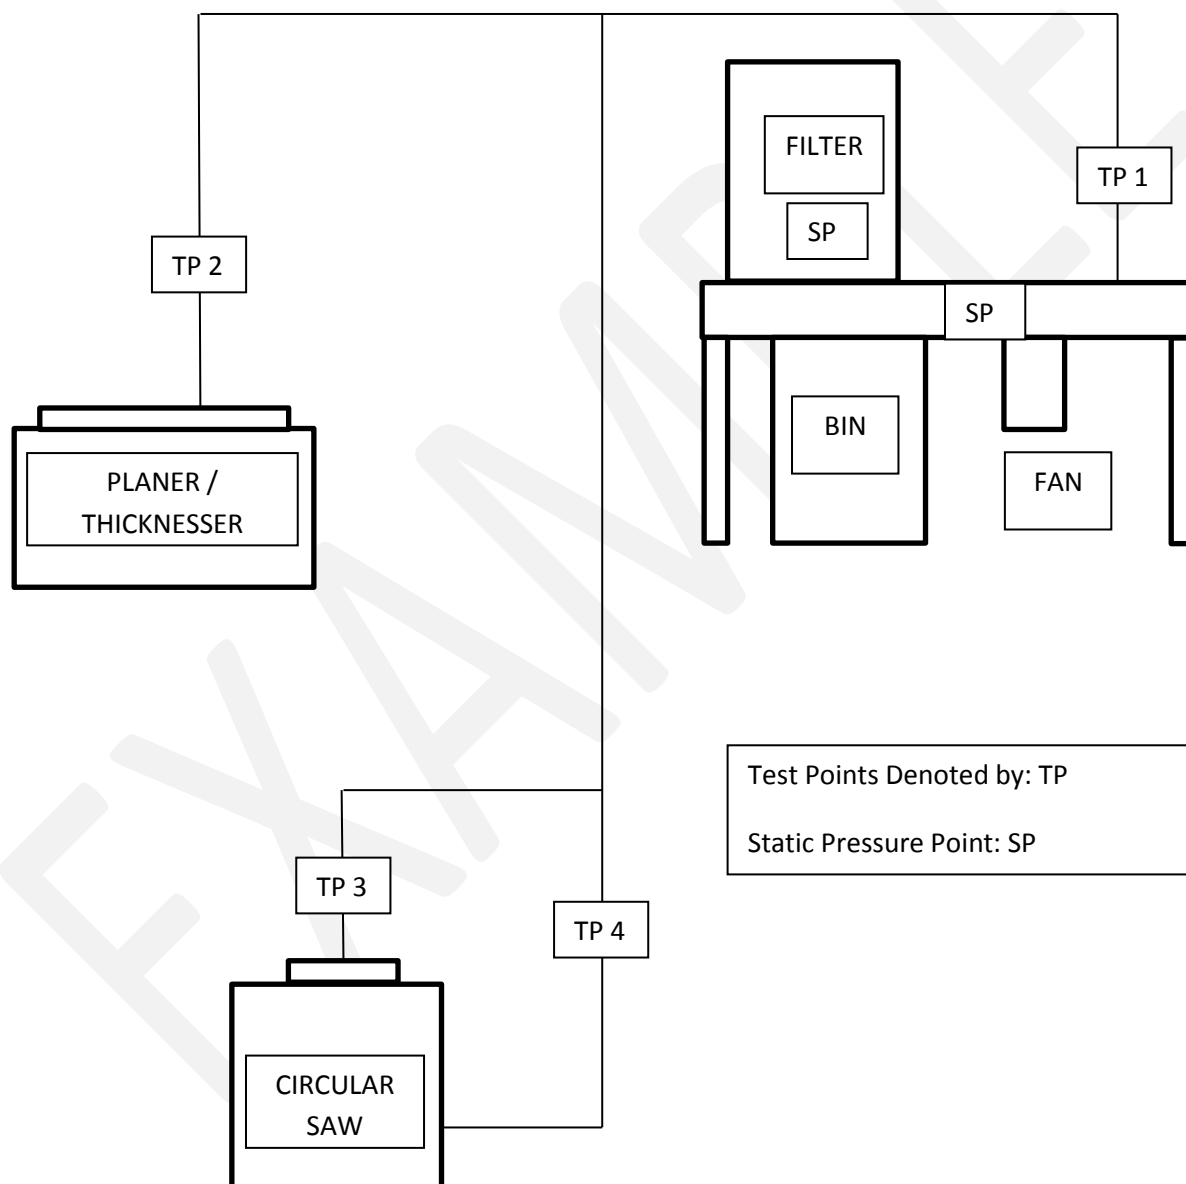
SYSTEM DETAILS

ENCLOSURES AND HOODS		Maximum number to be in use at any one time		3	
<i>Hood No</i>	<i>Location / Position</i>	<i>Static Pressure (kPa)</i>		<i>Face Velocity (m/s)</i>	
		<i>Measured</i>	<i>IOP</i>	<i>Measured</i>	<i>IOP</i>
1	Planer / Thicknesser	- 0.16	-	6	-
2	Circular Saw Blade Top	- 0.12	-	7.5	-
3	Circular Saw Blade Bottom	-	-	4	-

DUCTING						
<i>Duct No</i>	<i>Dimensions (mm)</i>	<i>Cross Sectional Area (m²)</i>	<i>Transport Velocity (m/s)</i>		<i>Volume Flow (m³/s)</i>	
			<i>Measured</i>	<i>IOP</i>	<i>Measured</i>	<i>IOP</i>
1	200	0.02	16.31	-	0.33	-
2	125	0.01	16.81	-	0.17	-
3	80	0.05	7.06	-	0.35	-
4	160	0.02	14.71	-	0.29	-

FILTER/COLLECTOR							
<i>Specification</i>	<i>Volume Flow (m³/s)</i>	<i>Static Pressure at inlet (kPa)</i>		<i>Static Pressure at outlet (kPa)</i>		<i>Static Pressure across filter (kPa)</i>	
		<i>Measured</i>	<i>IOP</i>	<i>Measured</i>	<i>IOP</i>	<i>Measured</i>	<i>IOP</i>
Cloth Bag	1.14	0.86	-	0.1	-	0.76	-

FAN OR AIR MOVER				
<i>Specification</i>	<i>Rating (kW)</i>	<i>Direction of Rotation</i>	<i>Volume Flow (m³/s)</i>	<i>Static Pressure at inlet (kPa)</i>
Centrifugal	2.2	Anti Clockwise	1.14	-1.09
